2020 SUMMARY FOR CHISAGO LAKES LAKE LEVEL MONITORING ACTIVITIES

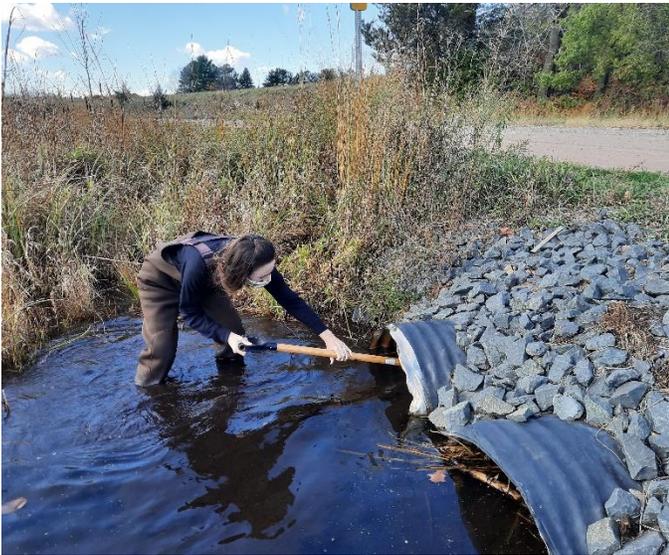
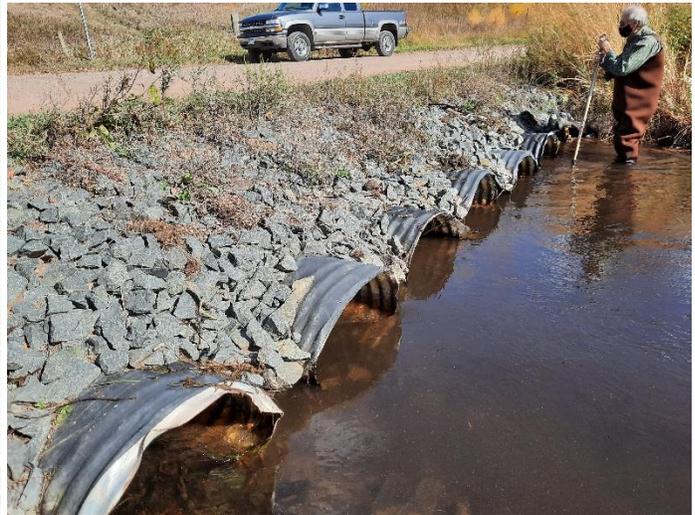
7. **Swamp Lake:** There are 7 culverts located at Swamp Lake; the 2nd culvert from the east is used for lake level measurements. Staff noticed low levels of water flowing through the culverts during lake level monitoring in October. On October 13, staff inspected the culverts and found significant vegetation and plant debris, as well as rocks, in all of the culverts, which caused them to plug and stop water from flowing through the culverts. County and EOR staff and volunteers removed more of the rocks located in the culverts during the Fall Channel and Outlet Structure inspection on October 29, 2020.

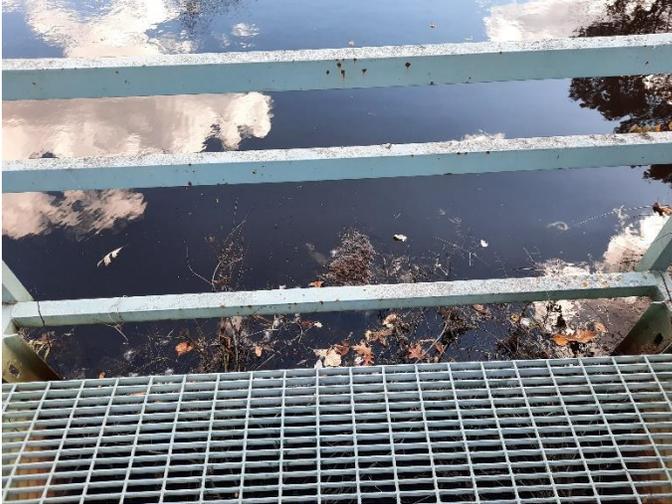
8. **Weir at Ivywood Trail:** The weir is used for measurements. County and EOR staff cleared excess vegetation located at the weir during the Summer Channel and Outlet Structure Inspection on August 20, 2020.
