CR 20 GULLY STABILIZATION

ROCK LINED CHANNEL

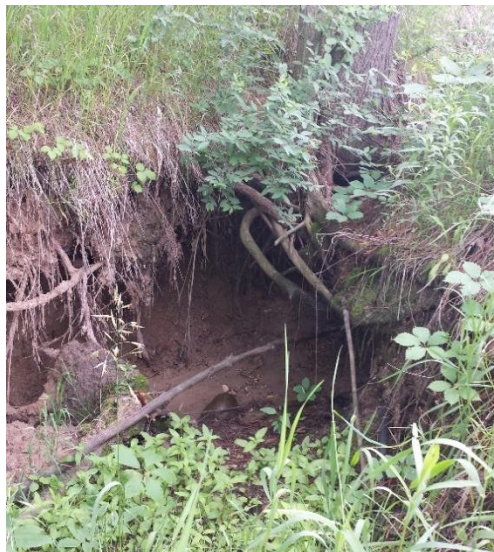
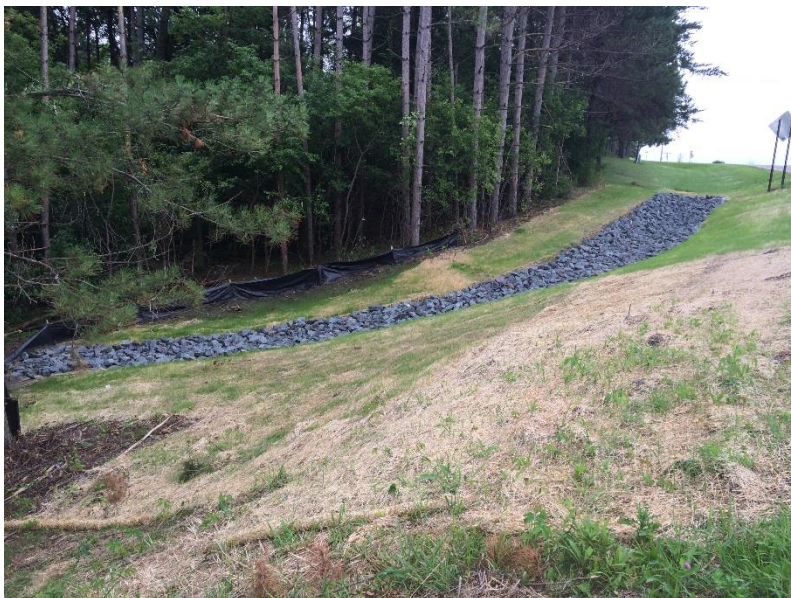
Stormwater runoff within the ditch alongside County Road 20 north of Lindstrom was causing active erosion within a gully. Each time it rained, the gully head was cutting more and washing more sediment down the gully into North Center Lake.

In partnership with Chisago County Public Works Department, Chisago SWCD was able to stabilize the gully in the summer of 2015. The gully was re-shaped, lined with a heavy protective fabric and then lined with rocks. Water can navigate the rock-lined channel without causing erosion of the sediment underneath.
