OLINDA TRAIL GULLY

GULLY STABILIZATION

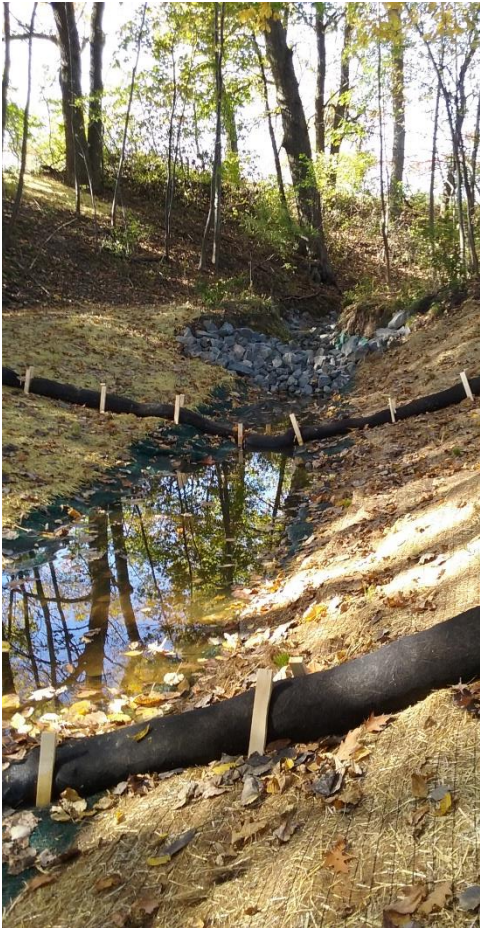
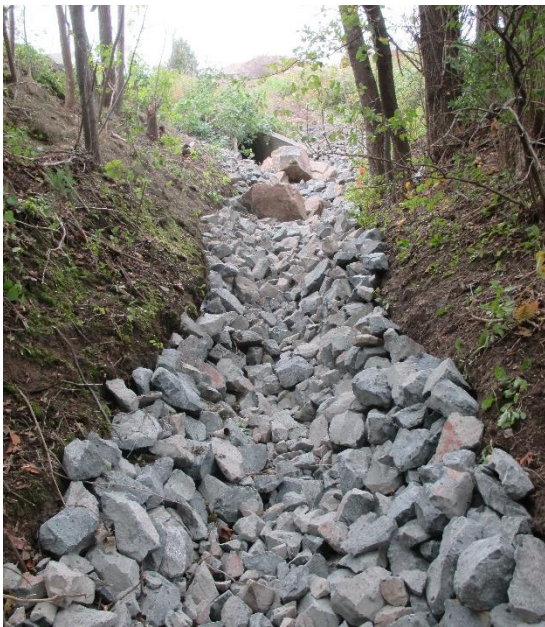
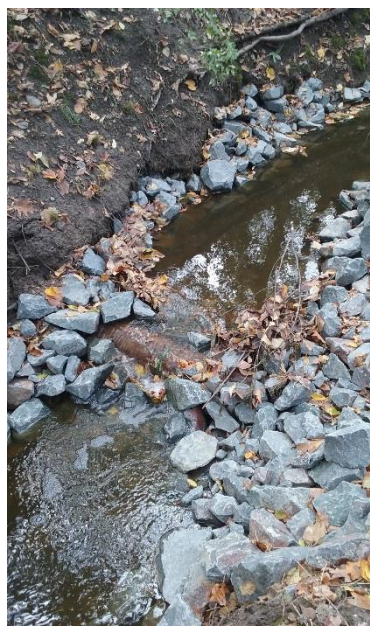
In the fall of 2016, a very large gully leading directly to South Center Lake was stabilized. This project was a priority to reduce sediment and phosphorus loading to South Center Lake. The large, actively eroding gully ranged from 2-8 feet in depth and 4-10 feet in width. Permanent Turf Reinforcement Mat was anchored to the bottom of the channel. Rock and log checks were spaced throughout the channel to slow the water down and reduce the rate at which the water could cut through the channel. The Chisago Soil & Water Conservation District worked closely with the landowners to ensure the outcome was acceptable to them and achieved maximum water quality benefits. An incredible 25 pounds of phosphorus is kept out of the lake each year by this stabilization project.
