NELSON LANE SOUTH

CHANNEL STABILIZATION & VEGETATED SWALE

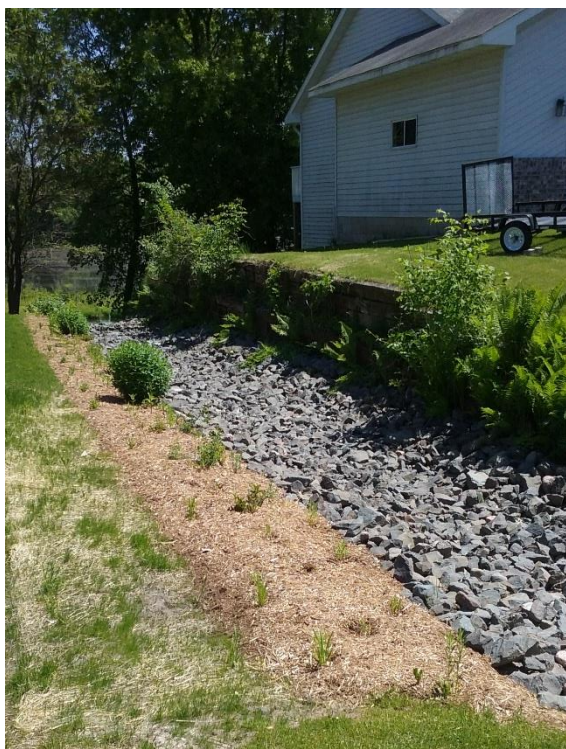
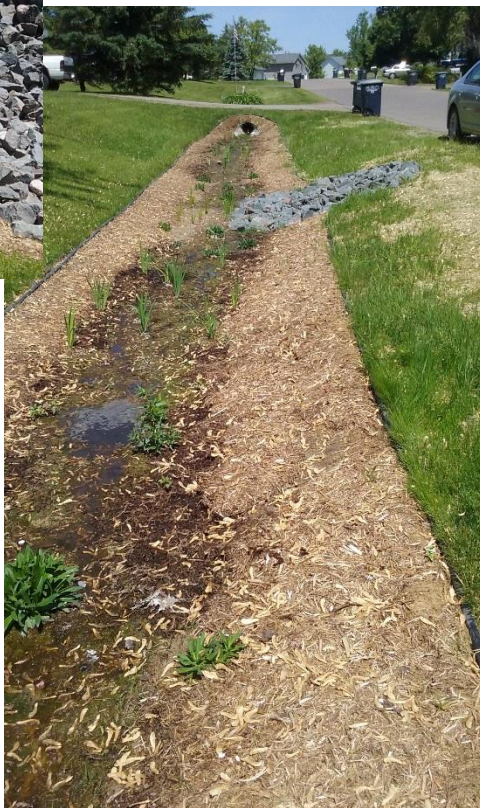
An eroding gully in Center City was adding tons of sediment to Pioneer Lake each year through a City stormwater outfall. The landowners and City agreed to fix the erosion by installing a rock-lined channel. Within the watershed, landowners agreed to install a 400 foot long vegetated swale to slow and filter the water that ultimately enters the large gully. Along with rock rip-rap for energy dissipation and erosion control, native plants were planted to filter water and stabilize the soil beneath the moving water.
