LAKE AVENUE DEAD END STREET PROJECT

VEGETATED SWALE WITH ROCK CHECK DAMS

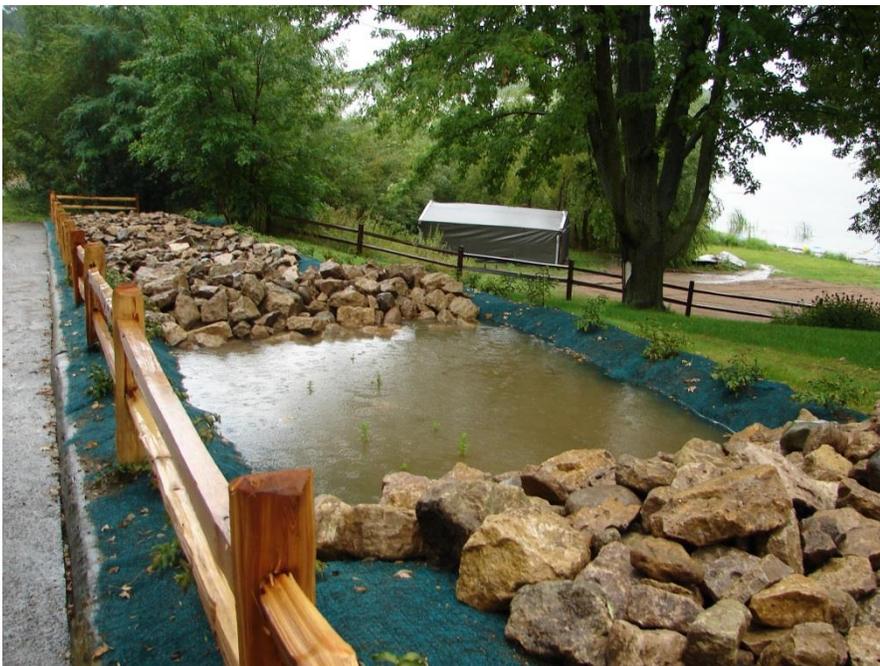
One half of the road was removed and replaced with a series of vegetated basins and rock check dams. The stormwater pipe was also daylighted early, so that the water enters the basins before reaching the lake. Water fills the basins and overflows through the rock to the next lower basin. The water in the basins can soak into the ground, where it is filtered. Winter access to the lake is maintained in a single-lane drive.
